Efficient, Conservative Treatment of Symptomatic Cracked Teeth

Jack D Griffin, Jr, DMD, FAGD
Private Practice
Eureka, Missouri

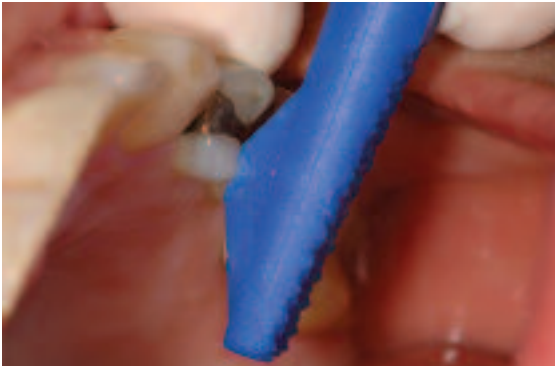
Figure 1—All teeth in a symptomatic quadrant are checked with the Tooth Slooth IIa after ruling out pulpal or periodontal pathology. The dimpled end is placed on every cusp tip and held there as the patient closes.

The concave end of the instrument is placed on each cusp in a suspect quadrant (Figure 1). The patient is then asked to close straight onto the stick and bite with firm pressure. Then the patient response is recorded (Figure 2). When loading the symptomatic cusp, the pain is readily noticeable by the patient as similar to that which is felt when the patient eats or bites. Every cusp must be loaded methodically so that an acute diagnosis can be made. Every cusp is checked at least twice to verify the sensations; the treatment plan should include at least that cusp in the final restoration.

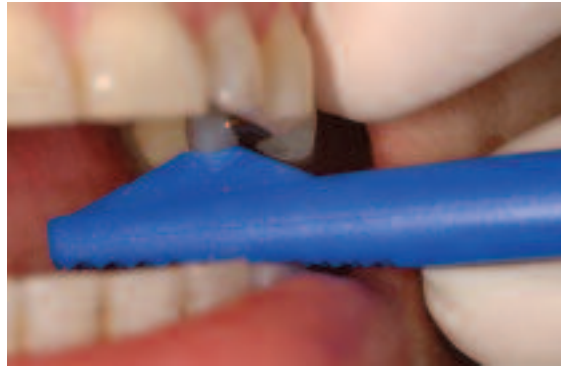
Figure 2—The patient is asked to bite straight down with firm pressure. Each cusp is checked and re-checked in a suspect quadrant until the symptoms the patient complained of are reproduced.

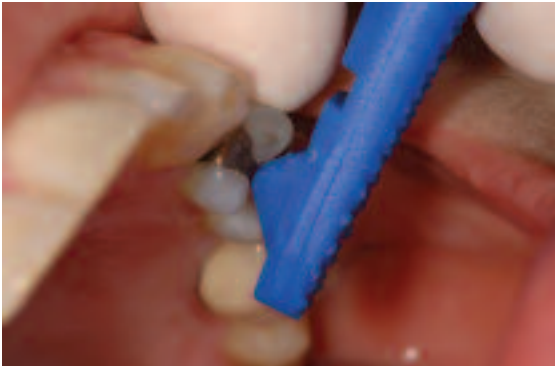
Figure 3—The pointed end is then used to load each central fossa and all occlusal fillings. The Tooth Slooth is held firmly on the fossa or filling while the patient closes.

The pointed end of the instrument is used to load each occlusal restoration and every central fossa to determine if the tooth has a mesial-distal fracture (Figure 3). In the same way, the patient closes with firm pressure, trying to repli-

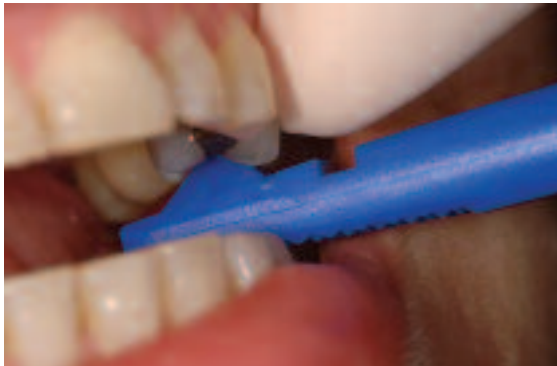
Figure 4—The patient bites down and results are recorded. Even though a positive test may have been given on a cusp tip, the fossa and fillings also must be checked to determine the extent of the restoration.

cate the symptom (Figure 4). Occasionally, newer posterior composites can cause CTS-type pain when loaded because of inadequate bonding of the restoration and consequential dentinal tubule fluid movement. This would indicate that the restoration should be replaced. Should the central fossa be symptomatic, a treatment plan must be made to at least replace the central fossa filling, and may include bonding or covering all cusps to prevent propagation of a mesial-distal fracture.

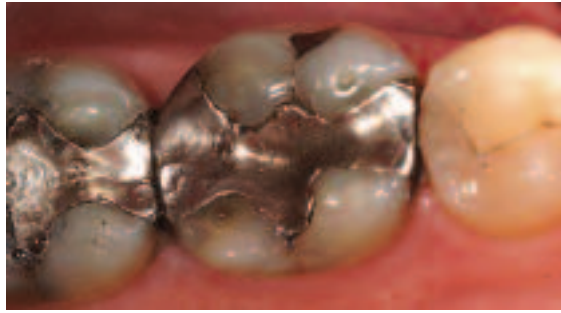
Figure 5—Examination revealed sharp pain reproduced when loading both buccal cusps of tooth No. 19. All other cusp tips or fossa were checked in this quadrant and found to be asymptomatic.

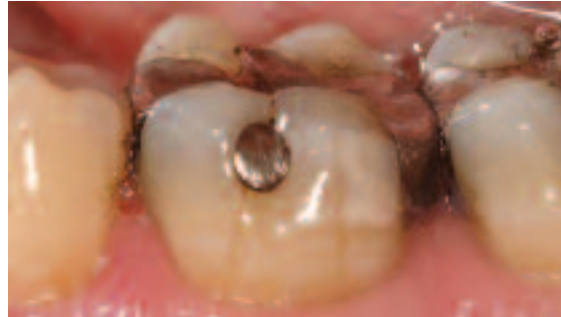
Figure 6—The buccal view shows craze lines running vertically down each cusp.

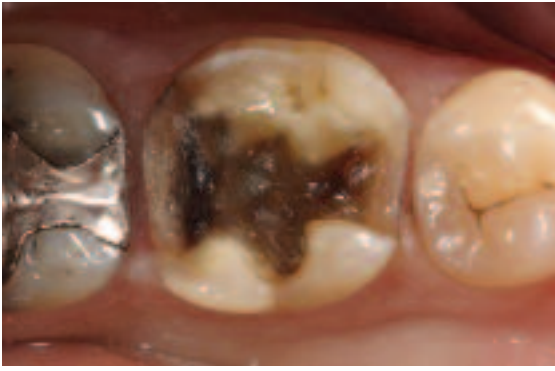
Figure 7—Initial preparation included removing the amalgam and reducing only the symptomatic cusps. Caries indicator was then used and the tooth was inspected for large cracks and decay.

bonding, but the craze lines on the mesial and distal boxes were left intact because they were free of caries and well-approximated (Figure 7). All amalgam, base material, and decay were removed and the symptomatic cusps were reduced at least 2 mm occlusally to provide ample clearance for porcelain thickness during excursive movements (Figure 8). The buccal and interproximal margins were rounded shoulders of about 2 mm to give ample porcelain thickness for resistance to breakage. All internal points and angles were rounded to decrease stress accumulation within the porcelain.

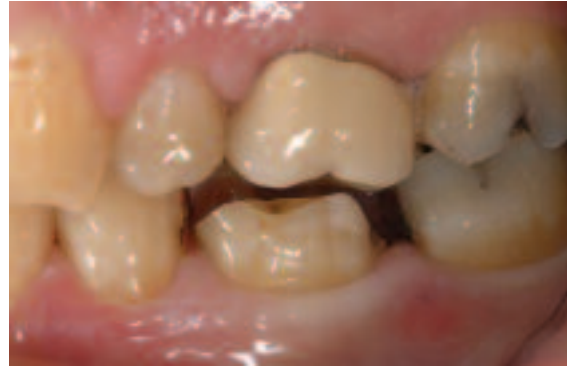
Figure 8—After completion of the restoration there was a minimum of 2 mm clearance in all excursive movements, and all margins were rounded shoulders with no internal sharp line angles.

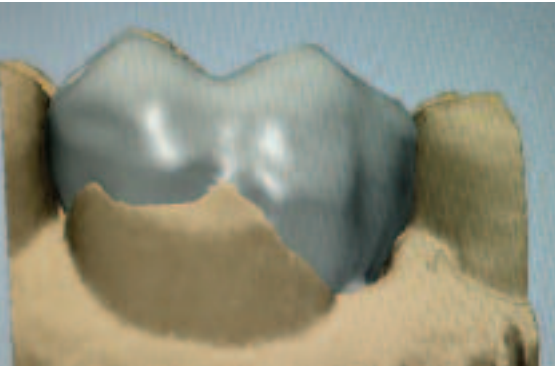
Figure 9—Cerec “Dental Database” design mode was used. The computer proposed this design according to a library of computer data and the anatomy of the adjacent teeth.

The prepared tooth was powdered with titanium dioxide reflecting powder and scanned into the Cerec computer by the acquisition unit. In about 5 minutes the restoration design was completed in the Dental Database mode. This design mode uses anatomy of adjacent teeth and a computer stored library of data to propose a restoration (Figure 9). The anatomy, marginal ridge heights, and contacts were

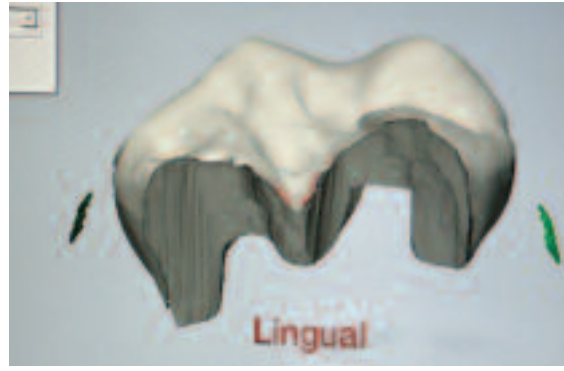
Figure 10—After operator editing, the restoration was finished and ready to be milled. A minimum of 1.5 mm to 2 mm of porcelain was incorporated into the design for ample porcelain strength.

checked and enhanced and the final restoration was inspected on the computer screen (Figure 10). Milling of Vita Mark II⁶ porcelain was completed in about 20 minutes. This Vita porcelain is reported to have excellent properties and great esthetics, and to wear opposing teeth comparably to enamel.¹⁵

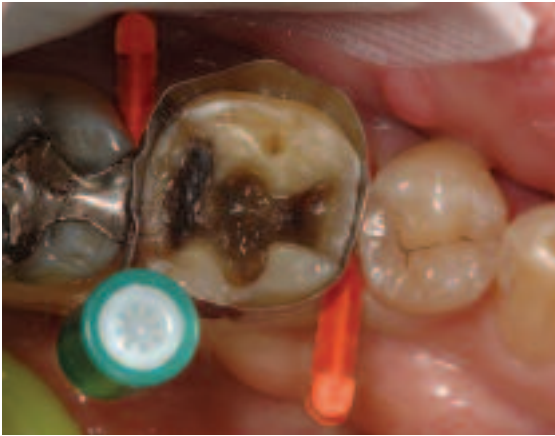
Figure 11—A matrix was placed on the tooth and secured with wedges. The matrix provides isolation for the tooth and helps ensure that the luting agent will not block embrasures and hinder flossing.

The porcelain was tried in, contacts adjusted, and fit verified with very little adjustment. A metal Hawe Adapt SuperCap Matrixi was used to isolate the tooth and control the flow of the composite luting material to help ensure unhindered flossing. A Dry Tip^j was placed on the buccal to retract and control parotid moisture while a Denta Pop^k was inserted on the lingual of the tooth to allow the patient to relax the mandible, keep the patient’s mouth open, and to retract the tongue. FlexiWedges^l were used to secure the matrix and prevent crevicular leakage (Figure 11).

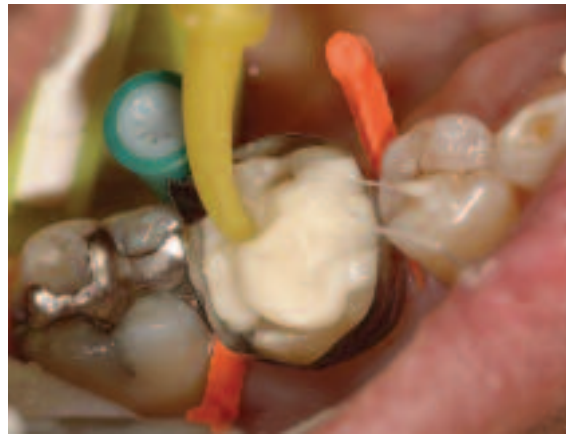
Figure 12—Build-It FR is injected directly into the matrix after the bonding agent is applied and cured.

Build-It FR was placed directly into the matrix from the automix gun (Figure 12). Before setting of the luting material, the restoration was vibrated into place with a Sonic Flex 2000^r hand-piece with a cementation tip for 5 seconds with firm pressure (Figure 13). This sonic vibration

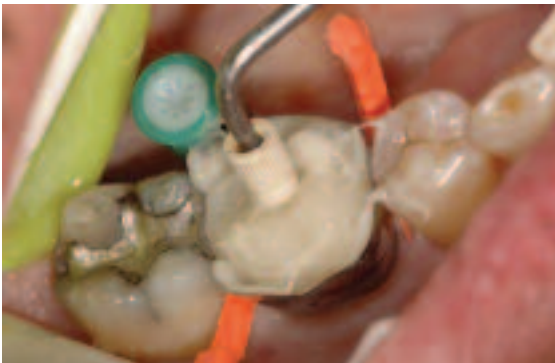
Figure 13—A cementation tip on an ultrasonic scaler is used to ensure complete seating of the restoration and to apply pressure to compensate for the thickness of the matrix band.

helps to ensure complete seating of the restoration and may reduce the marginal cement line thickness and decrease the chance of voids under the restoration.

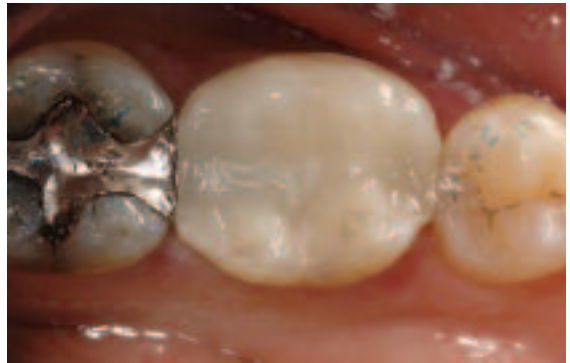
Figure 14—The restoration following clean up and bite adjustment. This is followed by anatomy fine tuning with a finishing diamond and then polished with rubber points.

Anatomy directly from the milling machine will need fine tuning once the occlusion is checked in all excursive movements (Figure 14). The occlusion was adjusted and contours were refined with a football diamond. The final anatomy was then placed with a finishing diamond, and porcelain polishing was initiated with a white stone^s, high-speed handpiece, and

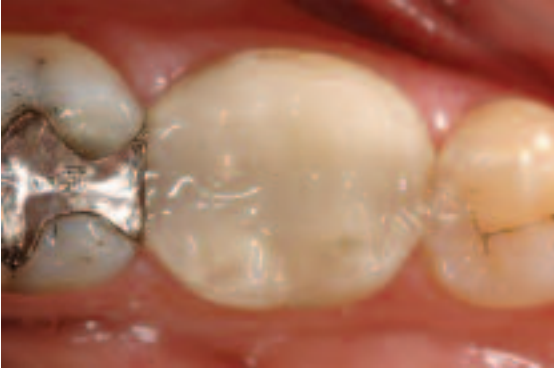
Figure 15—After 6-month recall appointment and follow-up for over 2 years, the tooth has remained symptom-free, with no eating or drinking limitations.

At the 2-year recall the patient remained symptom-free, and has had no further sensitivity to bite or temperature since the restoration was placed (Figure 15). After 2 years the margins remained stable, anatomy was very good, the color was acceptable, and the buccal craze lines had not increased in size (Figure 16).

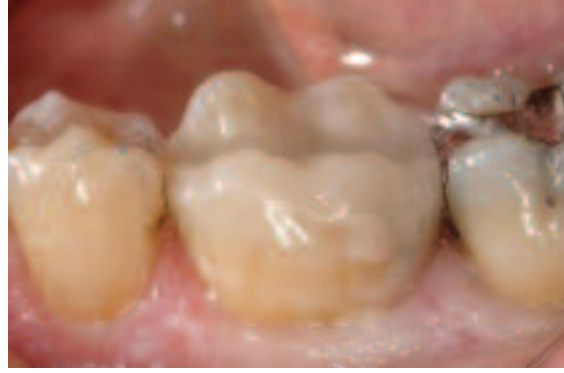
Figure 16—Buccal view more than 2 years after treatment shows excellent margins, reasonable wear, and no obvious growth of buccal craze lines.

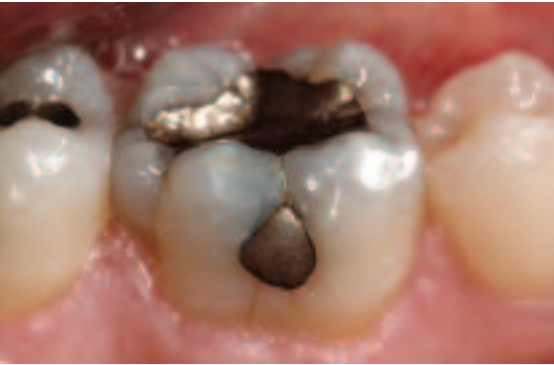
Figure 17—Symptomatic tooth with sharp pain when both lingual cusps were loaded and moderate pain when the restoration and central fossa areas were loaded. Some craze lines were found on the buccal from the pit amalgam toward the gingival.

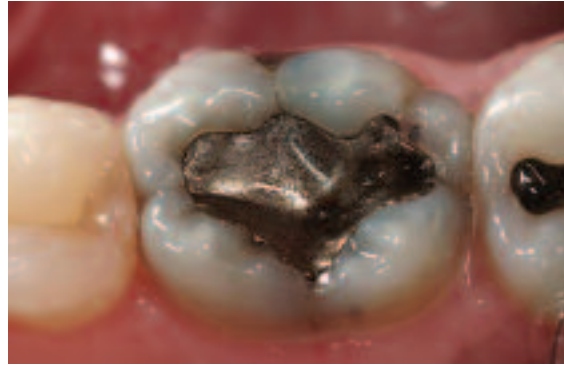
Figure 18—There are obvious cracks on both mesial and distal marginal ridges. The amalgam shows signs of leakage and has decay near its margins.

failing amalgam with leaking margins on tooth No. 19, and a smaller occlusal-buccal amalgam on tooth No. 18. Several craze lines were noticed on the facial and lingual, but all tooth segments seemed to be approximated well when the explorer passed over them (Figure 17). Larger cracks were seen on the mesial marginal ridge and the distal marginal ridge and running vertical down the lingual (Figure 18).

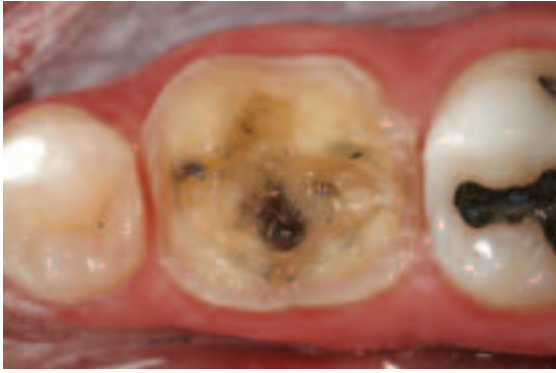
Figure 19—The preparation focuses on removing all old filling material, bases, and liners, and covers any obvious tooth cracks.

A shallow, fairly conservative amalgam was removed with a new 330 bur and the tooth was examined (Figure 19). From the occlusal view a mesiodistal crack was not obvious. Sable Seek^u caries indicator was applied. After checking twice with the caries indicator, all old restorative material and caries were removed, making

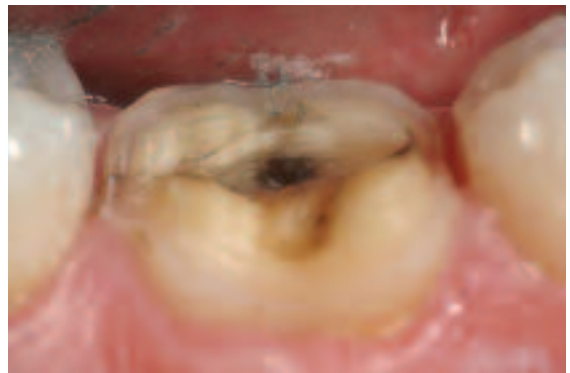
Figure 20—A preparation with 2 mm clearance and all decay and filling material removed. Note the fracture running from the mesial to the distal through the lingual cusps.

the crack more evident. It ran from mesial to distal under the lingual cusps when looking from the buccal (Figure 20).

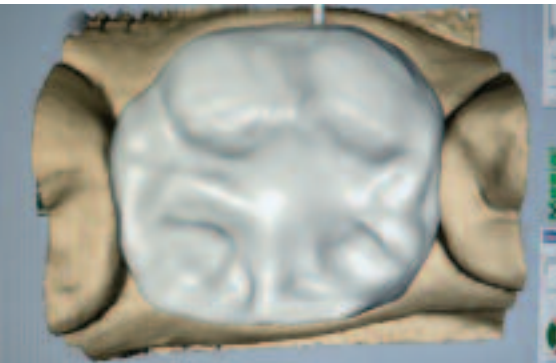
Figure 21—The preoperative anatomy of the tooth was copied into the restoration in the Cerec "Correlation" mode and slightly enhanced by the operator.

"correlation" mode (Figure 21). In this case, Pro-CAD^b porcelain, a leucite-reinforced porcelain with characteristics similar to Empress,¹⁹ was used. The porcelain was etched with hydrofluoric acid for 2 minutes, and silane coupler was applied and dried in 10 seconds. Then a bonding agent was applied, air thinned, and cured as described in Case 1. The restoration was cemented with Build-It FR, adjusted, and polished as described above (Figure 22). The patient was happy to again be able to eat without discomfort and reported no further sensitivity at each recall examination over a 2 year period (Figure 23).

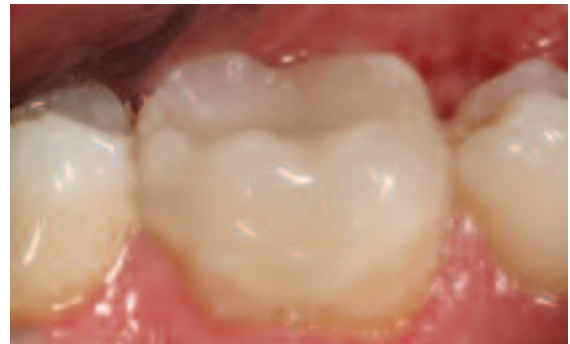
Figure 22—The restoration was etched, silanated, bonded, and luted into place with a resin build-up material. The occlusion was then checked and adjusted, and the restoration polished.

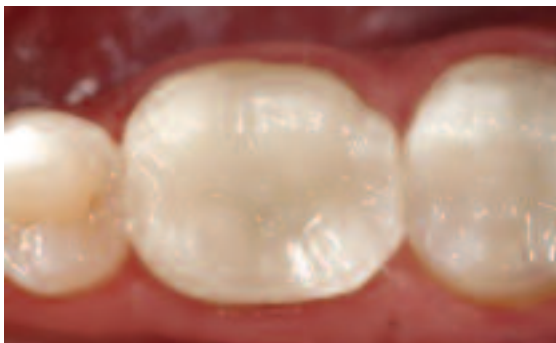
Figure 23—At recall appointment of over 2 years, no sensitivity was reported and the patient remained symptom-free.
