Smile Rehabilitation with CAD/CAM Veneers to Correct Rampant Decay

Jack D. Griffin, Jr, DMD*

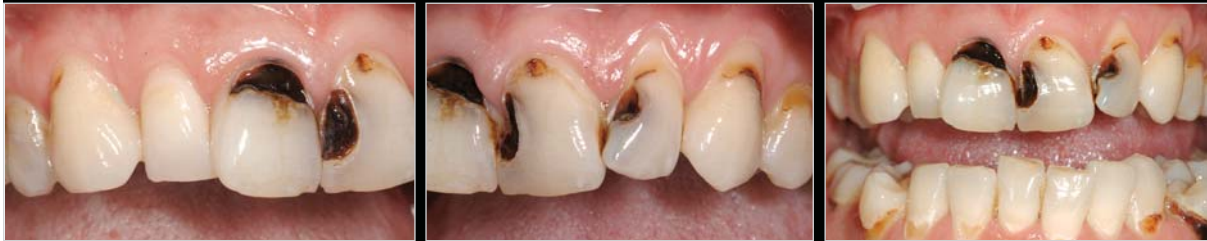
Figure 1. Preoperative view of tooth #8(11), which is rotated well out in front of the other teeth.

Figure 2. Teeth are rotated, showing crowding and thin lips as viewed prior to treatment.

Figure 3. Rampant decay exists and the patient desires aesthetic enhancement of her smile. Cervical decay was present on several teeth.

A female patient presented for aesthetic enhancement (Figures 1 through 3). She had a previous history of drug abuse but had not used drugs for several years. Clinical examination revealed widespread decay interproximally and facially. There were areas of 2 mm to 4 mm recession, and tooth #21(34) was out of the arch buccally with a poor prognosis. The anterior teeth were rotated and all had decay. All-ceramic restorations (ie, CEREC 3D, Sirona Dental Systems, Charlotte, NC) were treatment planned for teeth #6(13) through #11(23). Due to financial limitations, no posterior porcelain restorations were planned at this time, and porcelain restorations for the maxillary first premolars would be postponed for at least 1 year.

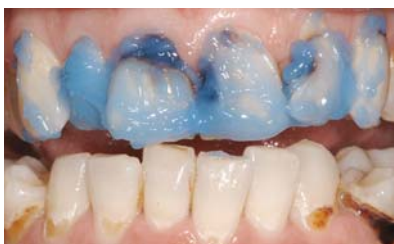
Figure 4. To begin the mockup, the teeth were etched and rinsed before composite placement.

An intraoral mockup, created via a direct resin technique, was used to aid in the determination of incisal edge position for proper phonetics and aesthetics.^{5,6} The teeth were etched with 37% phosphoric acid to ensure the materials would remain bonded during fabrication of the CAD/CAM restorations (Figure 4). A diode laser was used to enhance gingival contours, to create favorable emergence profiles for the central incisors, and to improve the symmetry of the restorations (Figure 5).⁷

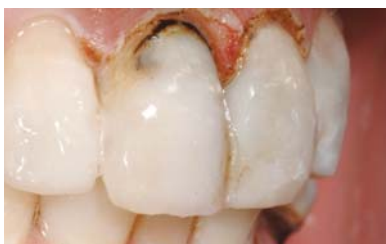
Figure 5. Laser recontouring was accomplished to enhance tissue shape and symmetry as well as improve the crown ratios for the central incisors.

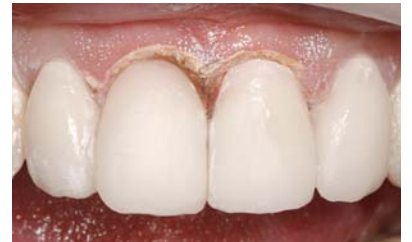
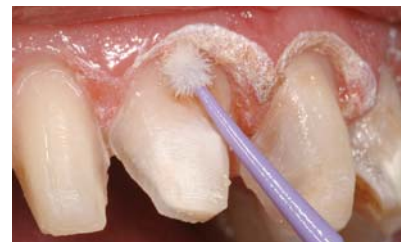
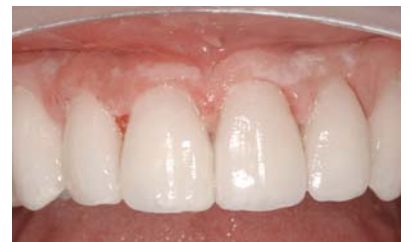
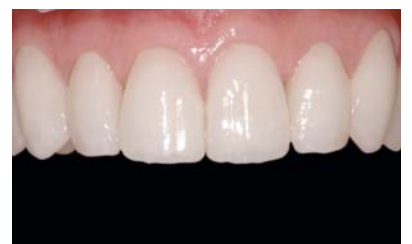
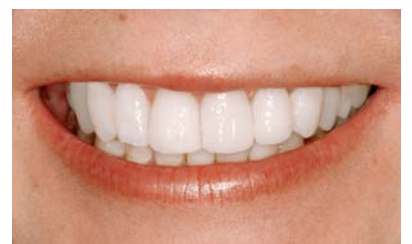
Figure 10. Once all four incisors were milled, they were tried in. Basic refinement was performed with a finishing diamond.

Figure 11. The teeth were rinsed and scrubbed to eliminate any adhesive that may have interfered with tooth bonding.

Figure 12. The contours and customization were solely the responsibility of the office staff. Despite seeing areas of imperfection, the case was acceptable.

Figure 13. At two years postoperatively, the aesthetic enhancement achieved via the CEREC process was evident.

Figure 14. The patient was extremely satisfied with the outcome, contributing to her overall confidence.

When porcelain was milled for teeth #7 and #8(11), they were placed on the tooth, powdered, and imaged into the computer along with the next tooth (#8) to be prepared (Figure 9). During the initial try-in of all four incisors, the contacts, embrasures, facial contours, and incisal character were adjusted using a high-speed handpiece, water irrigation, and a fine finishing diamond (Figure 10).

The lips were retracted, and teeth were scrubbed with alcohol to remove powder adhesive, powder, and salivary proteins that could interfere with higher bond strengths (Figure 11). The teeth were then prepared for 30 seconds with 37% phosphoric acid, and a dentin bonding agent was applied and air thinned. Hydrofluoric acid etching was applied to the porcelain for 2 minutes and followed by silane application. A dual-cure bonding agent was then applied and air thinned on the veneers. Clean up was performed with brushes, scalers, floss, and gauze prior to curing.

The patient was scheduled for a follow-up in 3 days to check healing and make adjustments as necessary (Figure 12). The patient was pleased with the aesthetic enhancement of her smile. At one week, the tissues were nearly healed and the patient experienced no pain. The tissues were recovering well, and the patient was pleased with the outcome of treatment. Posterior restorations began at this time, as did the extraction of the patient's third molars and tooth #21.

A splint was fabricated to help protect the porcelain restorations from potential parafunctional habits. The patient returned after 15 months for additional restorative work. Conservative preparations were performed, and CEREC restorations were fabricated for the first premolar teeth using the correlation technique described above. Almost 2 years after beginning, the rehabilitation was completed and the patient was pleased with her enhanced appearance (Figures 13 and 14).
